FIRE RISK ASSESSMENT

Date: 18/06/2018
Address: St Thomas of Canterbury Court Station Road Mayfield
Postcode: TN20 6BQ

Full Property Name:	St Thomas of Canterbury Court
Full Property Address:	Station Road Mayfield TN20 6BQ
Date of Fire Risk Assessment:	18/06/2018
Name of Fire Risk Assessor:	Mark Crowter GIFireE
Overall Risk Level of Property:	LOW (3)

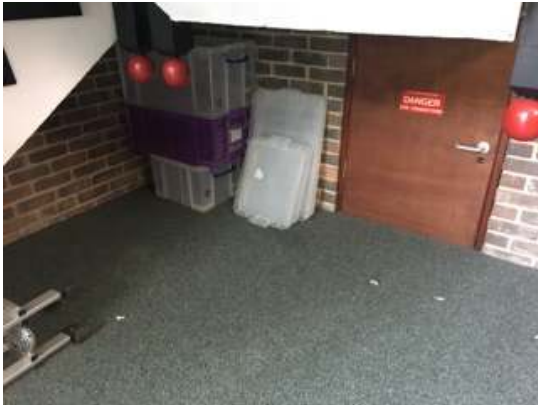
Photo 1

The following items were stored in the communal areas of the flats:

- Block 18-26. Items under stairs

REF	SIGNIFICANT FINDINGS	RECOMMENDATIONS	PRIORITY	COMPLETION DATE	COMMENTS	SIGN OFF
2.5.6	The following items were stored in the communal areas of the flats: <ul style="list-style-type: none">Block 18-26. Items under stairsBlock 18-26. Ground floor. Photos 1 and 2	The items must be removed and the areas kept clear.	2			
2.6.2 2.6.3	It is not known if safety conditions are imposed on contractors.	It is recommended that any hot works should be subject to a permit-to-work scheme. The use of a hot work permit is appropriate in circumstances where work will involve flames or sparks, where flammable materials are close by and when work is to be completed in environments where such activities are not normally carried out.	3

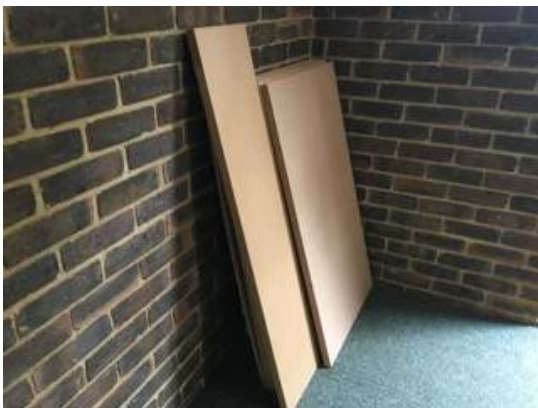
Photo 2

The following items were stored in the communal areas of the flats:

- Block 18-26. Ground floor.

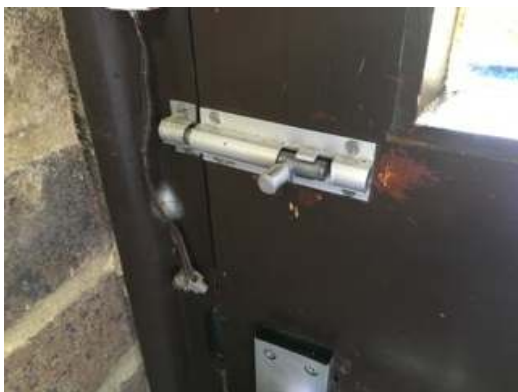
Block 7-12. The fire exit adjacent to Flat 9 is fitted with a barrel bolt.

It is not acceptable to fit barrel bolts to fire exit doors.

REF	SIGNIFICANT FINDINGS	RECOMMENDATIONS	PRIORITY	COMPLETION DATE	COMMENTS	SIGN OFF
3.1.7	Block 7-12. The fire exit adjacent to Flat 9 is fitted with a barrel bolt. It is not acceptable to fit barrel bolts to fire exit doors. Photo 3	The barrel bolt must be removed.	2

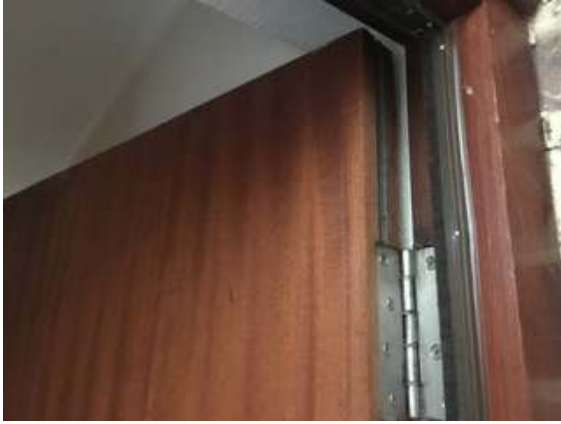
Photo 4

Access was available to Flat 14. It is fitted with an FD30s standard self-closing fire door. The front faces of the other flats were examined and they appear to be of the same standard.

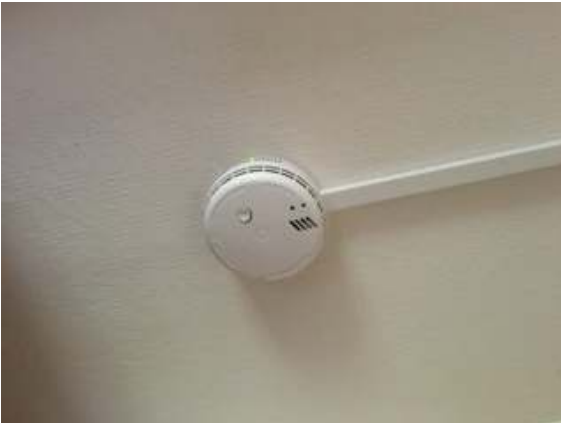
Photo 5

Flat 14. It is fitted with a mains powered smoke detector in the entrance hall. It is taken that this is the standard for all of the flats.
