**FIRE RISK ASSESSMENT**

<b>Full Property Name:</b>	The Cedars
<b>Full Property Address:</b>	Cedars Gardens, Withdene, Brighton BN1 6YS
<b>Date of Fire Risk Assessment:</b>	22/06/2018
<b>Name of Fire Risk Assessor:</b>	Mark Crowter GIFireE
<b>Overall Risk Level of Property:</b>	LOW (3)

1.1	DESCRIPTION OF PROPERTY	
REF	DETAILS	
1.1.1	Occupancy/Use:	Sheltered Accommodation
1.1.2	General Description	<p>The Cedars is a purpose built sheltered scheme comprising 25 self-contained flats. The buildings are of brick and concrete construction with the first floor flats opening onto open deck escape routes. Flats 18-21 have staircases at each end of the open deck escape routes. Flats 22-23, 25-26 and 5-7 have single direction escape routes. Ground floor flats have exits directly to open air. The open balcony design would allow smoke and heat to be mainly dissipated to open air in the event of a fire. The assessment includes the small communal lounge, laundry room and scheme manager's office. The boiler room is accessed externally and the buggy store is located in a purpose built garage.</p> <p>Key fire safety features in the buildings include BS5839 fire alarm system and BS5266 emergency li

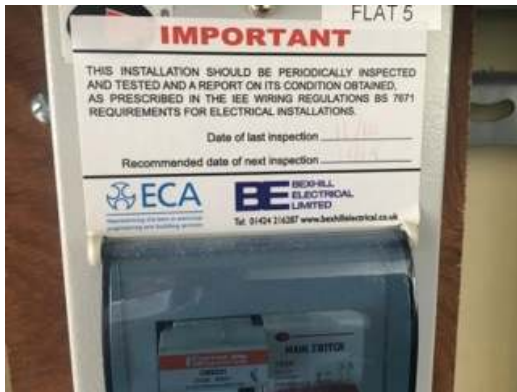
### Photo 1

Mains electrical installation has been tested in accordance with BS7671 5 yearly test. Next due November 2019.

2.1.1	Mains electrical installation has been tested in accordance with BS7671 5 yearly test. Next due November 2019. <b>Photo 1</b>	
2.1.2	There is evidence that portable appliance testing (PAT Testing) is undertaken regularly in compliance with the schedule in the Electricity at Work Regulations 1989. Tested 14/12/2017.

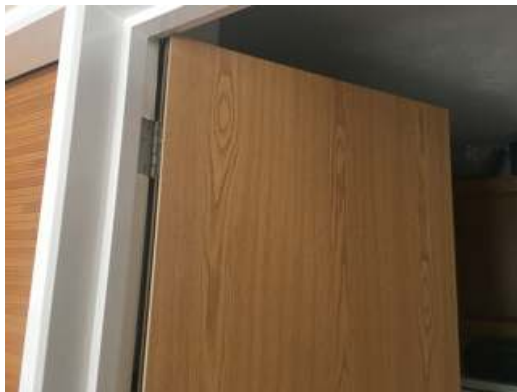
### Photo 2

The fire door to the kitchen is not fitted with a self-closer.

REF	SIGNIFICANT FINDINGS	RECOMMENDATIONS	PRIORITY	COMPLETION DATE	COMMENTS	SIGN OFF
3.2.4	The fire door to the kitchen is not fitted with a self-closer. <b>Photo 2</b>	The kitchen fire door must be fitted with a self-closer, which conforms to BS EN 1154.	2

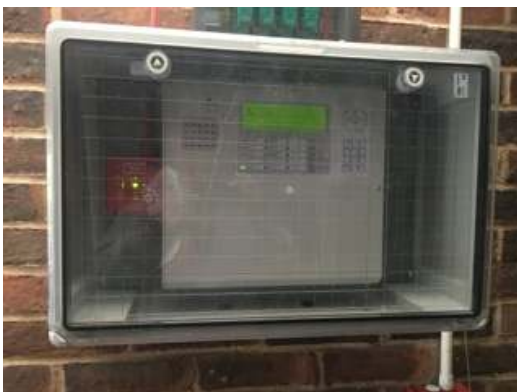
### Photo 3

There is an Addressable Fire Alarm System installed to comply with British Standard 5839 part 1. The control panel provides a simultaneous evacuation system within the premises, utilising Sounders as the audible means of alarm. Manual call points are generally situated at exits and along exit routes, and positioned so that no person has to travel more than 45 meters to activate a call point. There is a call point adjacent to each escape route exit to the premises. Automatic fire detection is provided in the escape routes and adjoining rooms.

At the time of the assessment, the fire alarm panel was showing healthy supply with no faults.

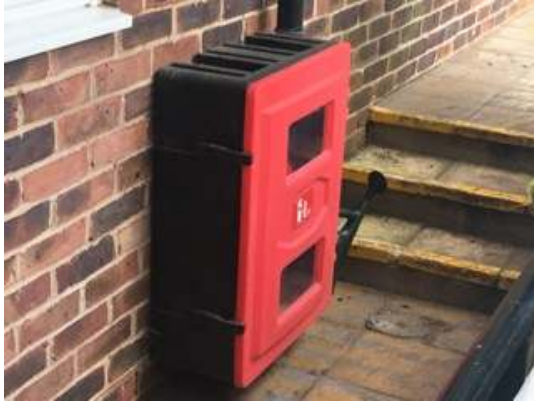
### Photo 4

There is over-provision of fire extinguishers to the open deck escape routes in the residential blocks.

REF	SIGNIFICANT FINDINGS	RECOMMENDATIONS	PRIORITY	COMPLETION DATE	COMMENTS	SIGN OFF
7.1.2	<p>There is over-provision of fire extinguishers to the open deck escape routes in the residential blocks.</p> <p>It is not considered necessary to provide fire extinguishers in the common parts of flats. Such equipment should only be used by those trained in its use. It is not considered appropriate or practicable for residents in a block of flats to receive such training. In addition, if a fire occurs in a flat, the provision of fire extinguishing appliances in the common parts might encourage the occupants of the flat to enter the common parts to obtain an appliance and return to their flat to fight the fire. Such a procedure is inappropriate.</p> <p><b>Photo 4</b></p>	<p>It is recommended that the fire extinguishers be removed from the open deck escape routes in the residential blocks.</p> <p>The extinguishers located in the lounge, kitchen, laundry room and office should remain.</p>	3
